Analysis of the causes of the crash of Flight MH17 (Malaysian Boeing 777)

1. The Event

4.3. Initial data from the crash site of the Boeing 777

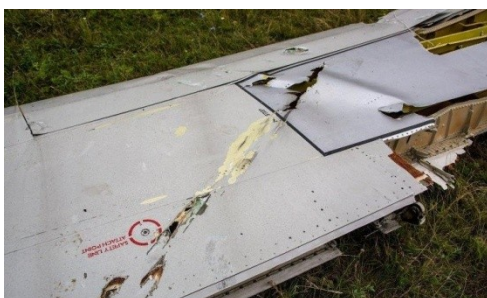
Picture 1. Fragment of the Boeing 777 plane
Фото 1. Фрагмент плоскости Boeing 777

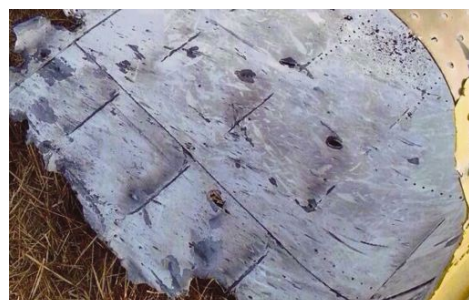
Photo 2. Fragment of the Boeing 777's shell
Фото 2. Фрагмент обшивки Boeing 777

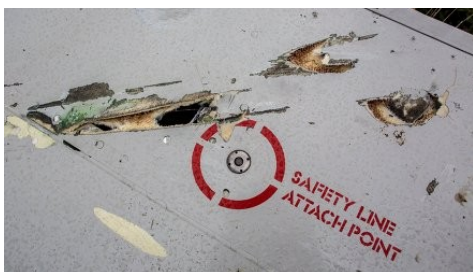
Photo 3. Fragment of the Boeing 777 plane
Фото 3. Фрагмент плоскости Boeing 777

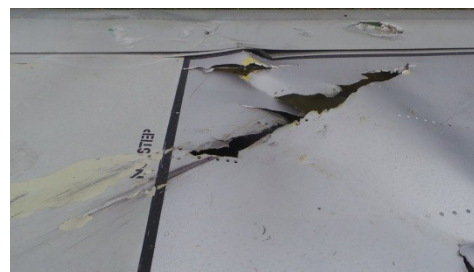
Picture 4. Detail of the Boeing 777 plane
Фото 4. Фрагмент плоскости Boeing 777

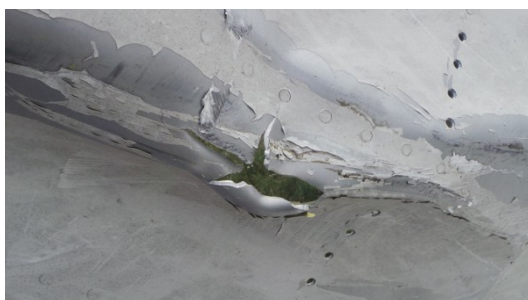
Picture 5. Detail of the Boeing 777's fuselage
Фото 5. Фрагмент фюзеляжа Boeing 777

Of particular note are the holes folded inward in the fuselage. They are round-bored, and usually grouped. Such holes can only be formed by metal objects with a circular cross-section, possibly rods or shells from an aircraft gun. The question arises: who could deliver such projectiles to the aircraft, by what means, and what might they look like?

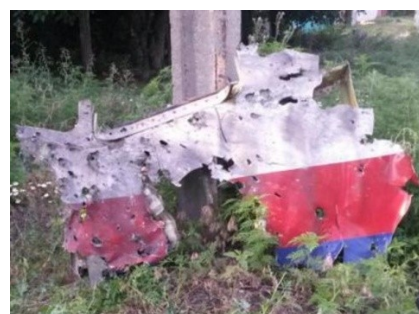
Photo 6. Detail of the Boeing 777 cockpit
Фото 6. Фрагмент кабины Boeing 777

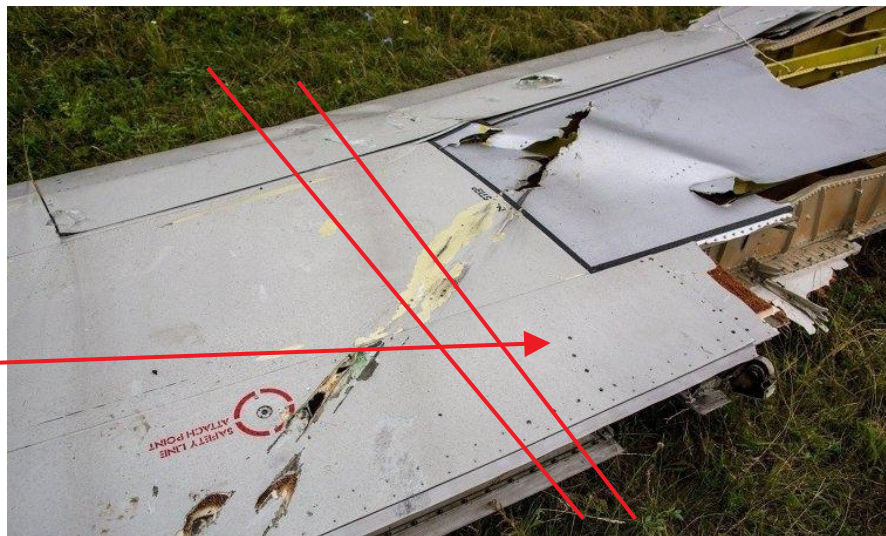
It would be logical to assume that the damage shown in photo 19 is more commonly associated with aircraft cannon shells of the GSH or SPPU type.

Damage to the Boeing 777 is not characteristic of the SAM "BUK-M1" missile

Photo 19. Damage to the flat surfaces of the Boeing 777
Фото 19. Повреждения плоскости Boeing 777

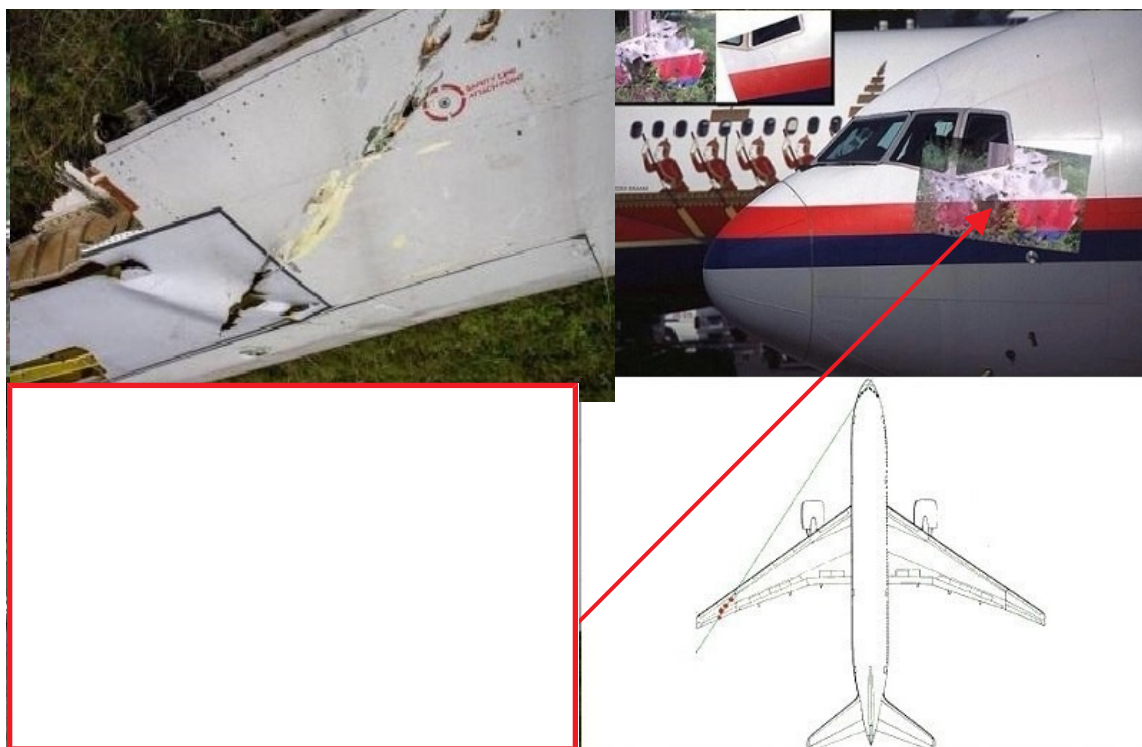
Photo 20. The nature of the damage to the cabin of the Boeing 777
Фото 20. Характер повреждений кабины Boeing 777

The picture of the entry and exit holes in the cockpit of the Boeing 777 are fully consistent with the passage through the flight of shells from the 20-30 mm caliber guns found on military aircraft. This confirms the second version of what brought down the Boeing. This is further supported by the way the puncture holes are dispersed along the surface of the aircraft. The edges of the fragment of the fuselage from the left side of the cockpit are folded from the inside outward, which indicates that a significant blast occurred within the cockpit as a result of the dynamic impact of the shells on the right side.

On the trim panel the characteristic entry holes are visible as well as some exit points. The edges of the holes are bent inward; they are much smaller and are circular in shape. The exit openings are less clearly formed; their edges are torn outward. In addition, it is clear that exit holes broke through double aluminum lining and tilted it outward. That is, the strike elements ([judging] by type of impact - aircraft cannon shells) punched right through the cockpit. The open rivets were also bent outward.

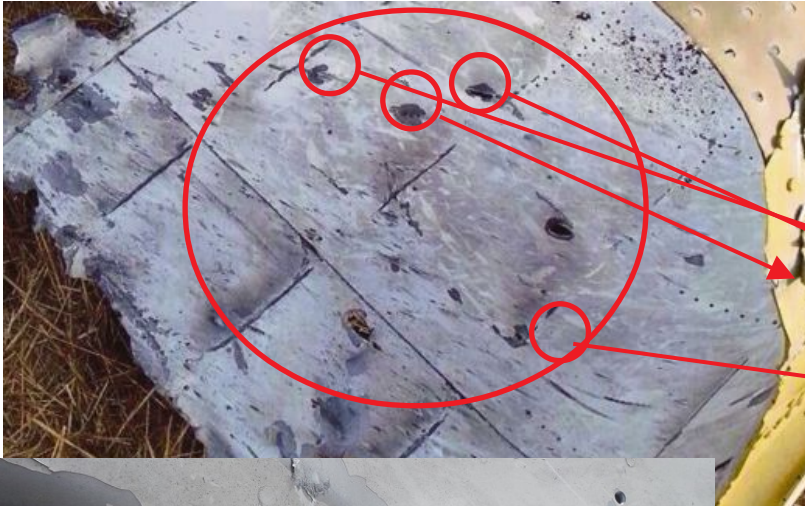
A fragment of the Boeing 777. Clearly seen are the entry holes in the outer layer, folded inward, caused by a 30-mm gun. **The inward folds are clearly seen, which are characteristic of this type of projectile.**

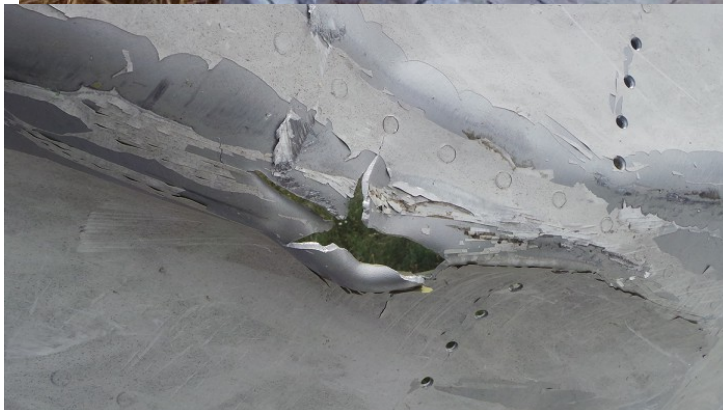
Photo 22. nature of the damage skin Boeing 777
Фото 22. Характер повреждений обшивки Boeing 777

Fragment of Boeing 777. Taken off the rivet.

Rupture of the fuselage from the inside to the outside edges of the impact blow that is caused by any explosion inside the airplane, or a sharp drop in internal pressure at high altitude
