Analysis of the causes of the crash of Flight MH17 (Malaysian Boeing 777)

1. The Event

4.3. Initial data from the crash site of the Boeing 777

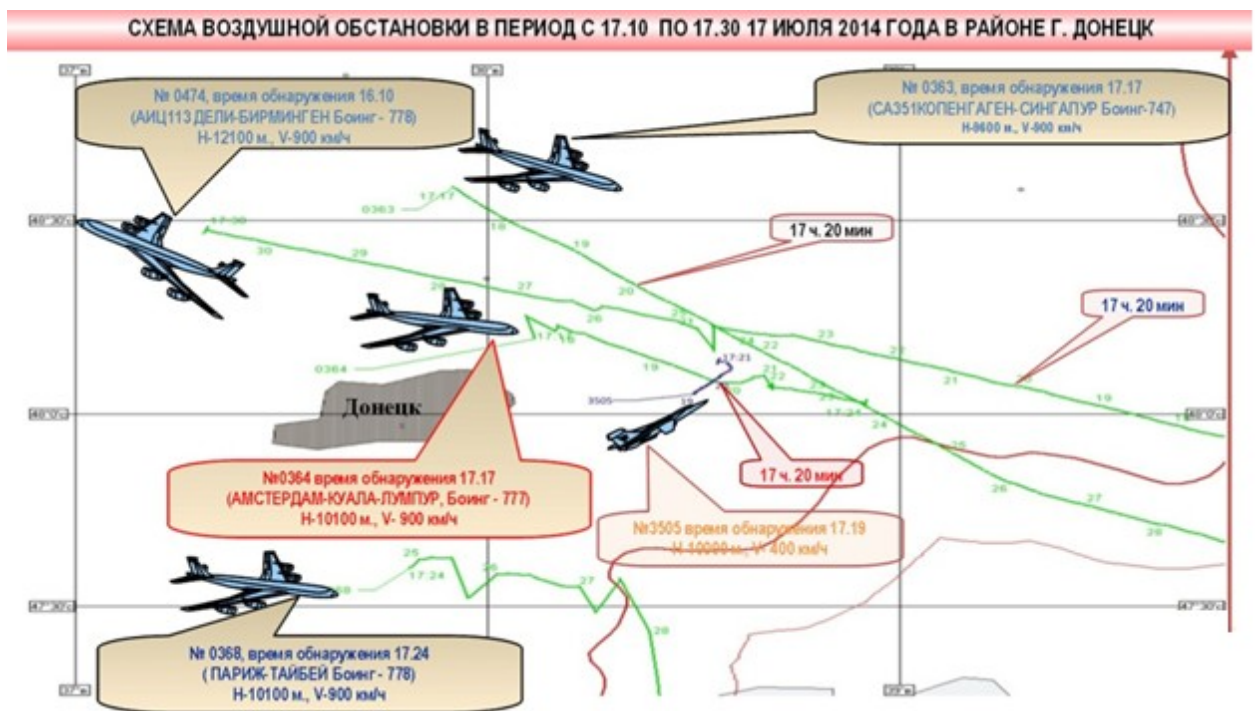
In addition, Russian air traffic control recorded the ascent of a Ukrainian Air Force aircraft, presumably an Su-25, in the direction of the Malaysian Boeing 777. The distance between the SU-25 aircraft from the Boeing 777 was between 3 and 5 km.

Fig.1 Diagram of the situation in the sky in the area where the Boeing 777 was destroyed (according to data from the Russian Federation Ministry of Defense)

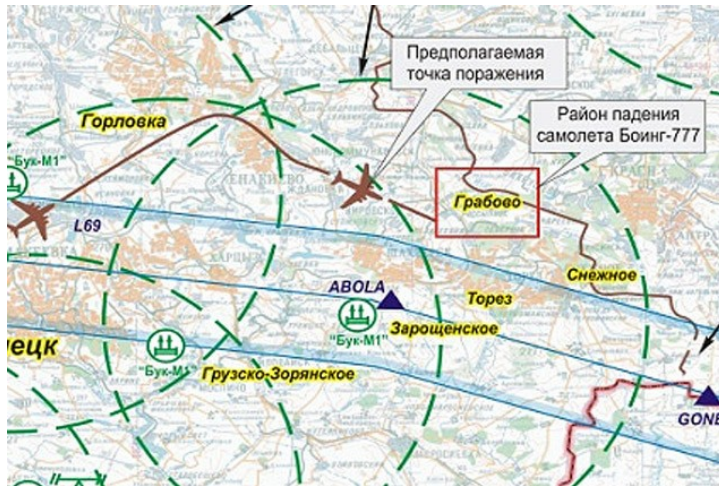
Fig.2. Grouping Ukrainian SAM
Рис.2. Группировка украинских ЗРК

Grouping of Ukrainian troops on July 17 in the crash site numbered 3-4 Position "Buk-M1." This was stated by the Russian Ministry of Defense. The Chief of the Main Operations Directorate of the General Staff, Lieutenant-General Andrew Kartoplov, stressed that the Russian side has pictures from aerial locations of the individual units of the Ukrainian army in the south-east of Ukraine, in particular, "Bukov," 8 km from Lugansk. And on the morning of the day a Malaysian aircraft came down, Russian monitors found a battery SAM "Buk-M1" near the village of Zaroschenskoe. That day it was moved to Donetsk - in the area where the militia are located. We believe these data are objective and accurate.

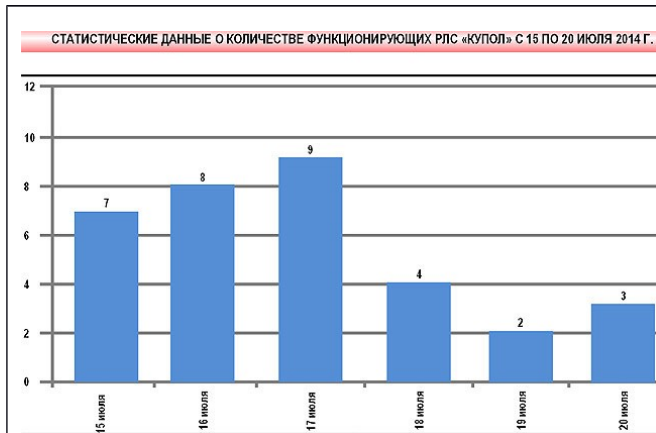
7.1.2. The Russian Defense Ministry said that Russian military radar detected the "Dome" Ukrainian air defense system battery "Buk-M1", working, on the day of the Malaysian Boeing 777 disaster.

Рис.3. Статистика активности украинских РЛС в районе гибели малайзийского Boeing 777
